# FY26 Safe Routes to School Safety Assessment Report

**Glenallan Elementary School**

October 2026

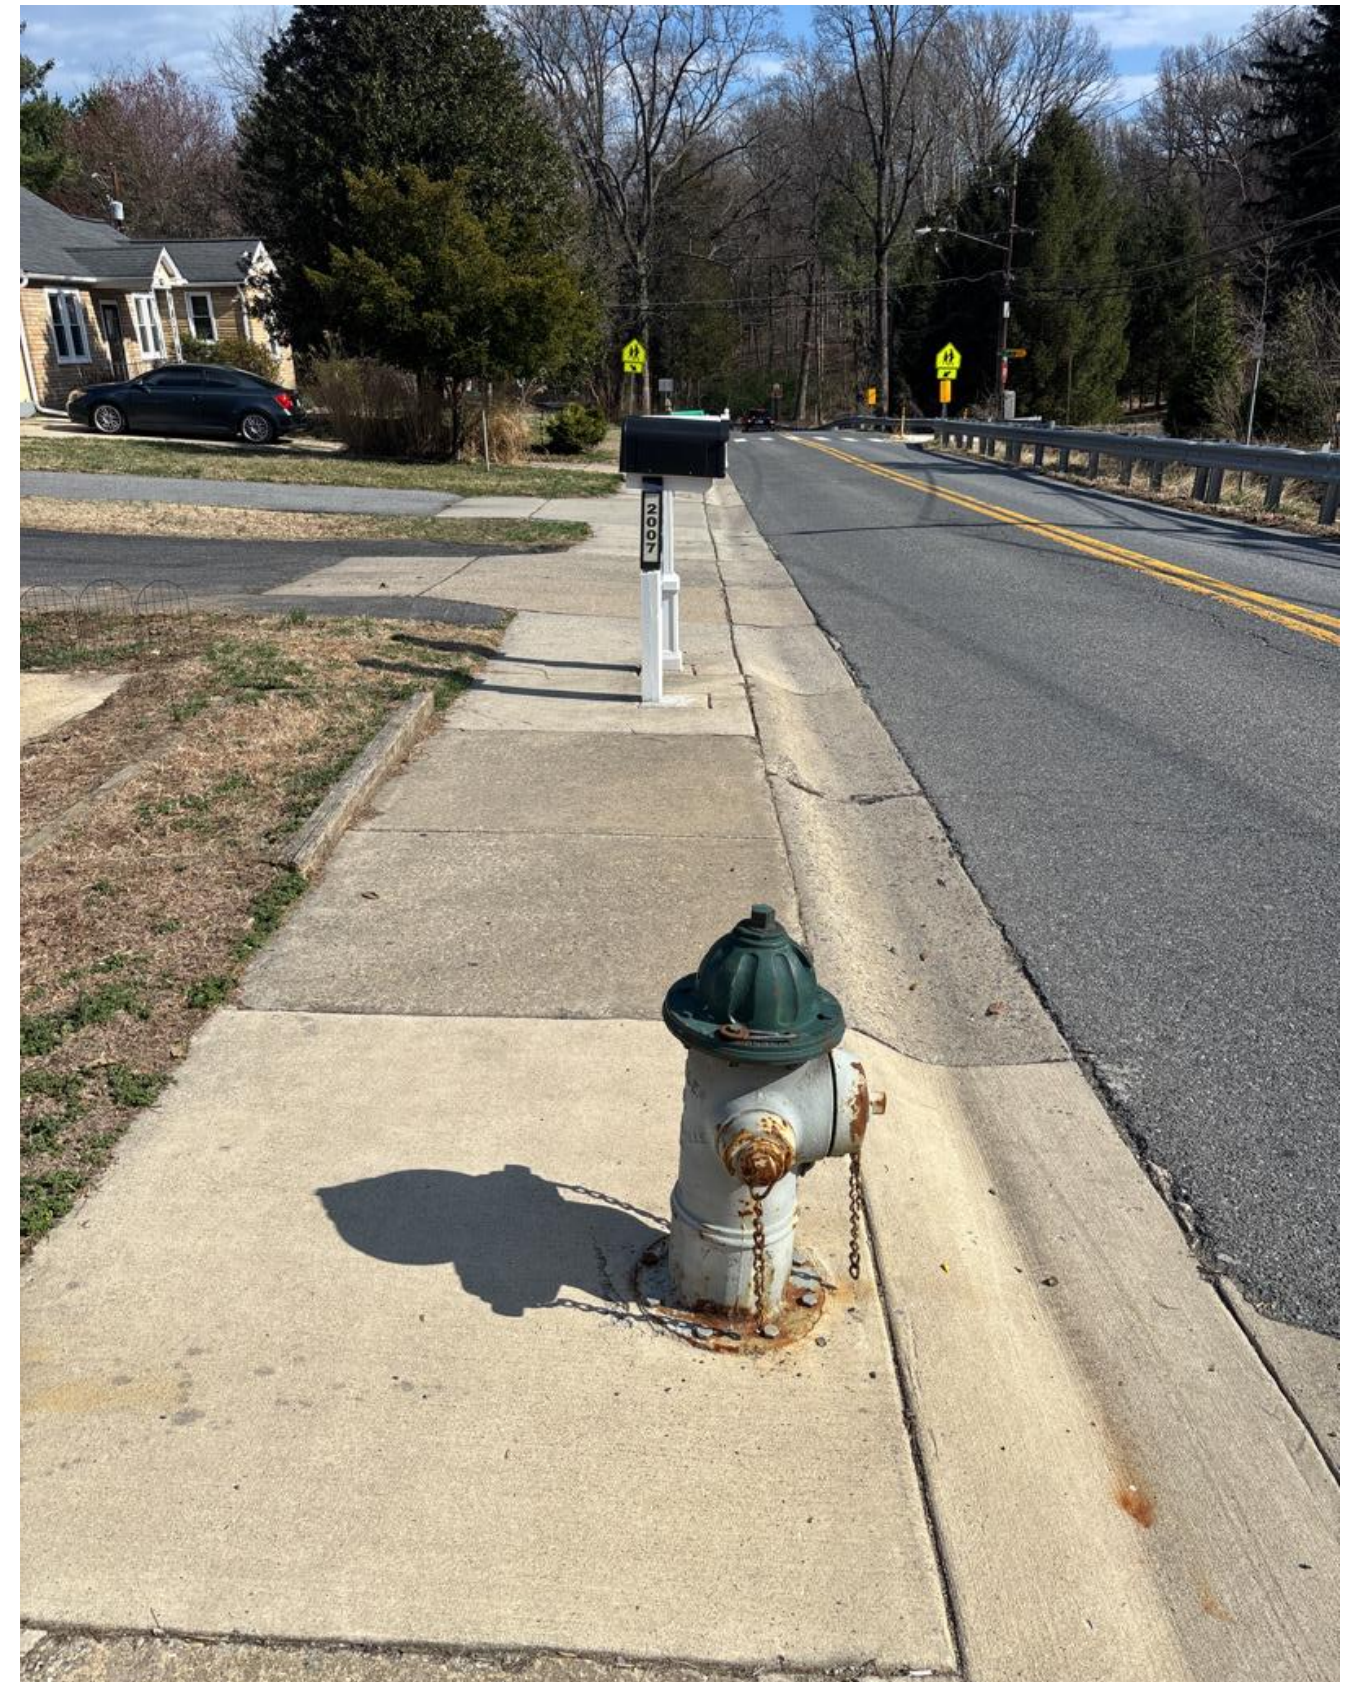
Glenallan Avenue sidewalk with utility and mailbox obstructions.

| MAP ID | LOCATION | ISSUE | RECOMMENDATION | COST | TERM | JURISDICTION |
|---|---|---|---|---|---|---|
| I4 | Glenallan Ave<br>(Wallace Ave to Randolph Rd) | North side of Glenallan Ave has continuous mailbox obstructions that narrow the sidewalk to <4 feet. | Relocate or remove obstacle. | \$ | Short | MCDOT |

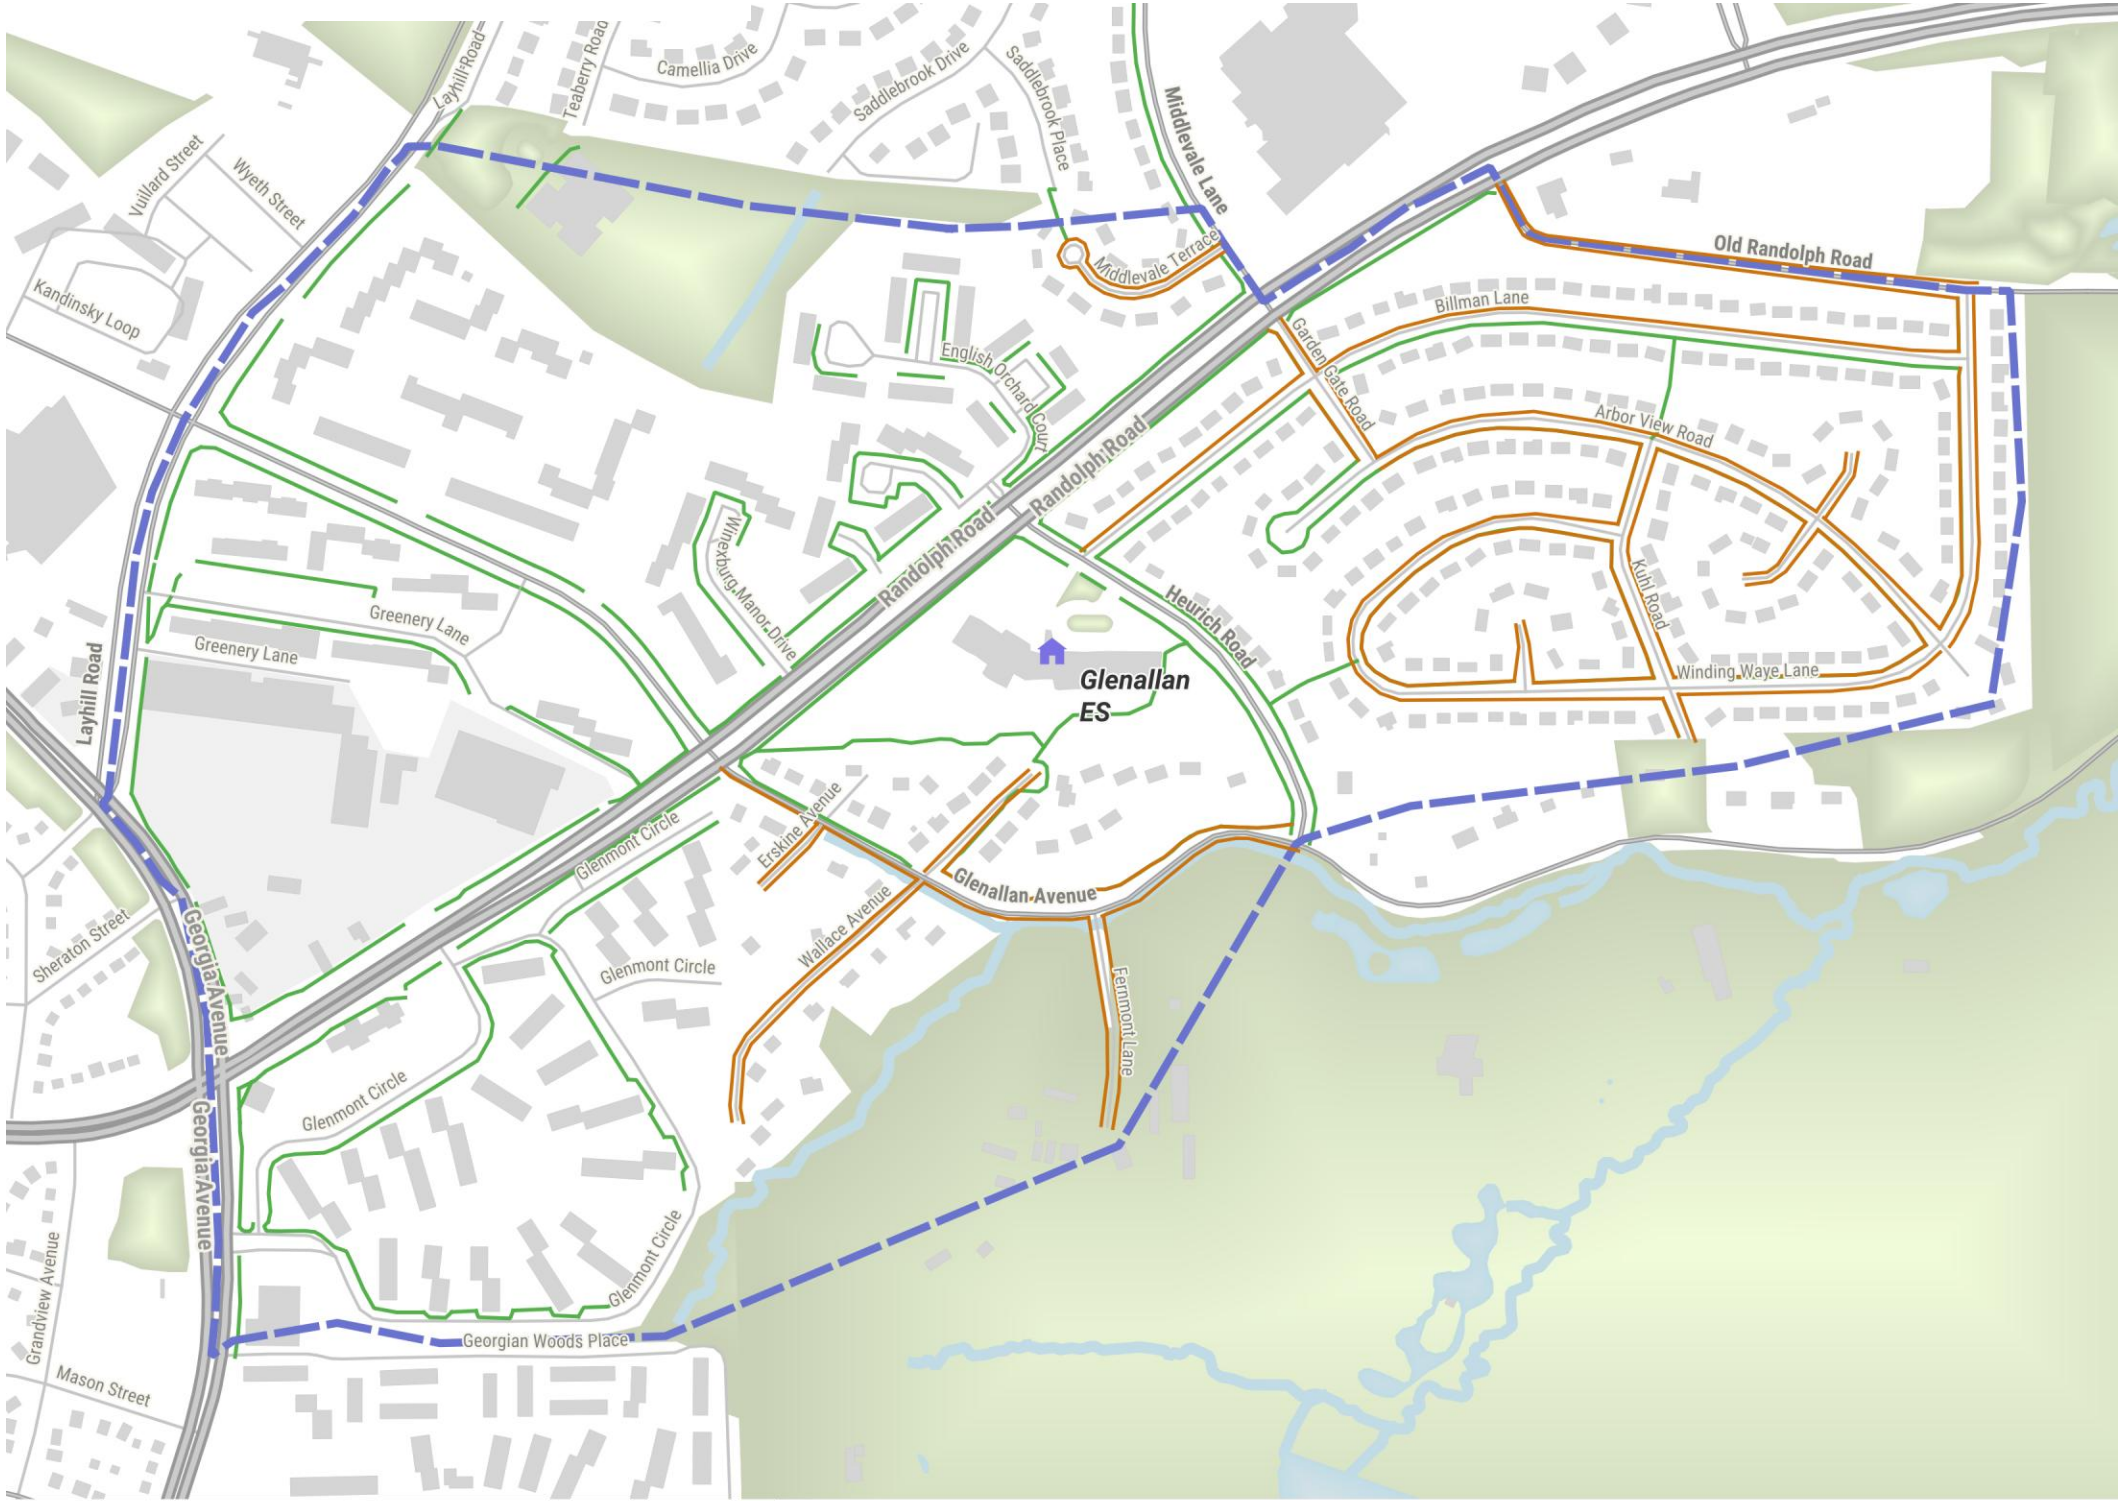
- Roadways abutting school property, including Randolph Road and Heurich Road, have sidewalk on both sides of the road.
- The residences located in the northeast side of the walkshed, from Billman Lane and Winding Way Lane, generally have sidewalk on one side of the road, with some cul-de-sacs having none.
- Some segments of Glenallan Avenue do not have sidewalk on one side, while Old Randolph Road, does not have sidewalk on either side.
- Much of the walkshed is comprised of privately owned and maintained streets. While those areas were not formally inventoried, there generally appeared to be sidewalk on at least one side of the road.
- Multiple obstacles were observed along sidewalks in the walkshed, including mailboxes and utilities, often reducing available width and accessibility.

Inventory does not include private developments.

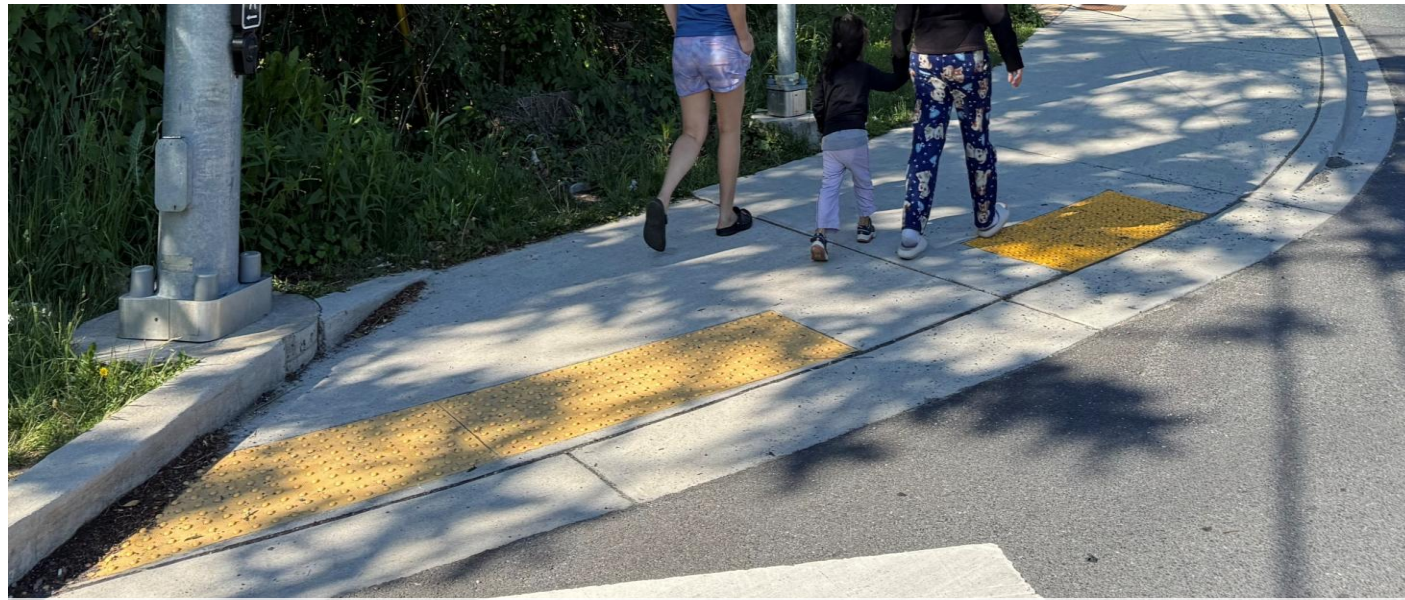
Curb ramp lacks grade separation at Glenallan Avenue and Randolph Road.

| MAP ID | LOCATION | ISSUE | RECOMMENDATION | COST | TERM | JURISDICTION |
|---|---|---|---|---|---|---|
| 13 | Glenallan Ave & Randolph Rd | Curb ramps on the southeast and southwest corner do not appear to be ADA compliant. | Reconstruct or repair existing ramp. | \$ | Short | MCDOT |

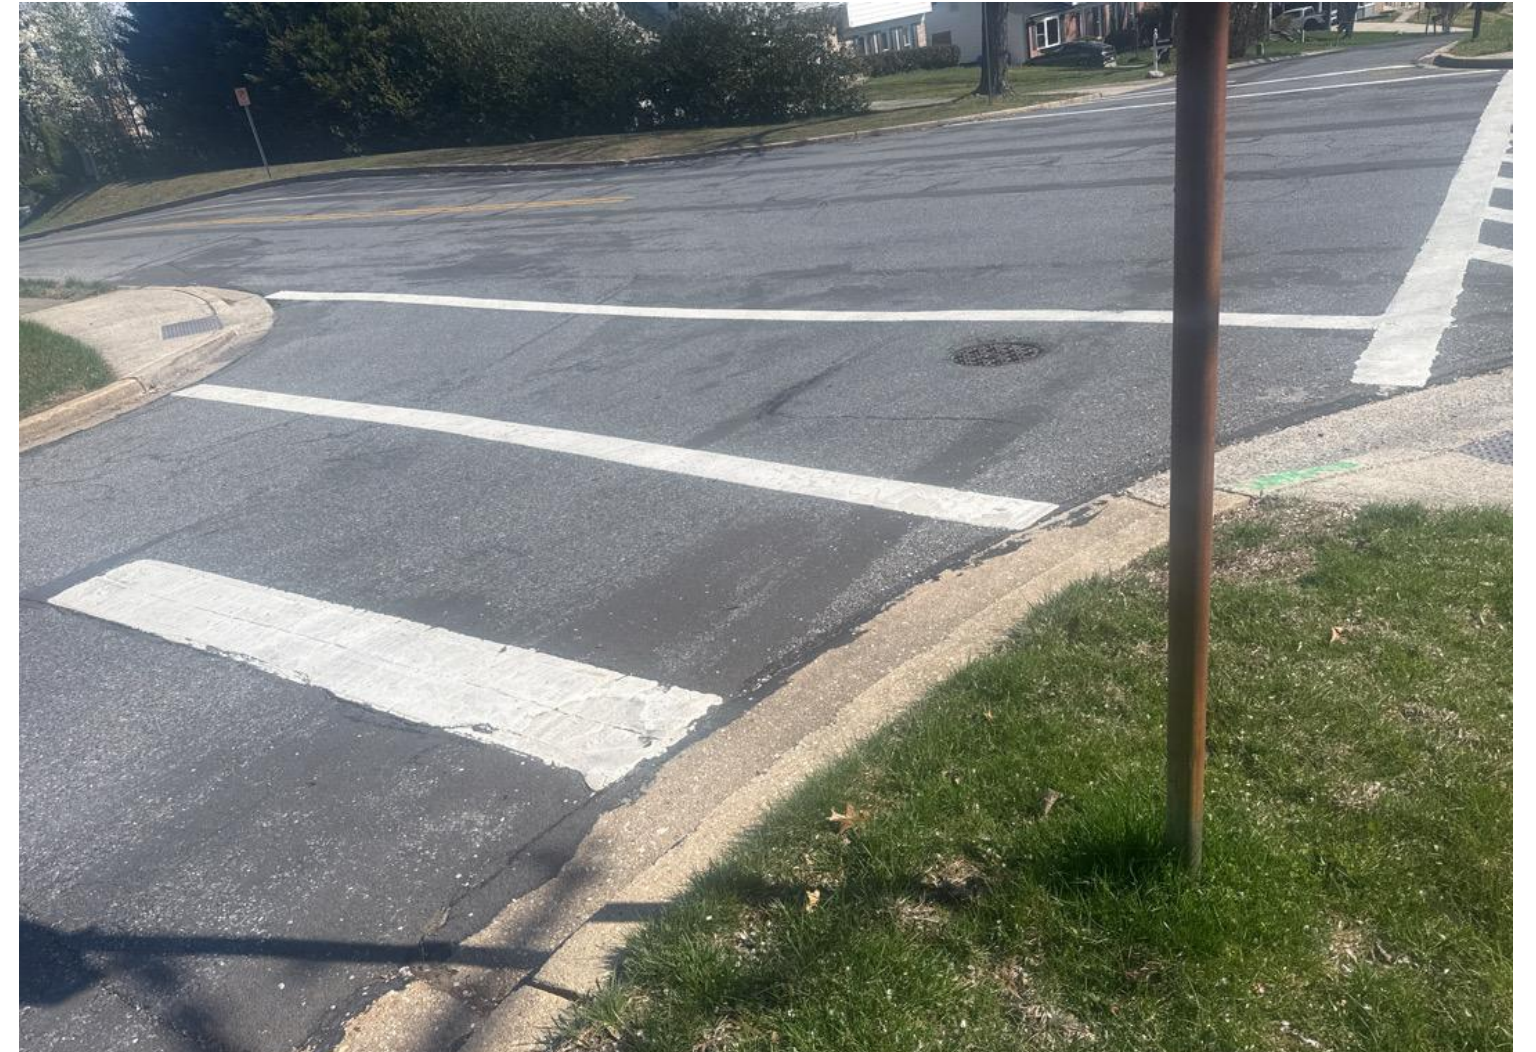
Crosswalk at Billman Lane and Garden Gate Road is not high-visibility.

| MAP ID | LOCATION | ISSUE | RECOMMENDATION | COST | TERM | JURISDICTION |
|---|---|---|---|---|---|---|
| 5 | Billman Ln & Garden Gate Rd | Crosswalks are not high-visibility across Billman Ln on both sides of Garden Gate Rd. | Remark existing crosswalk with high-visibility markings. | \$ | Short | MCDOT |

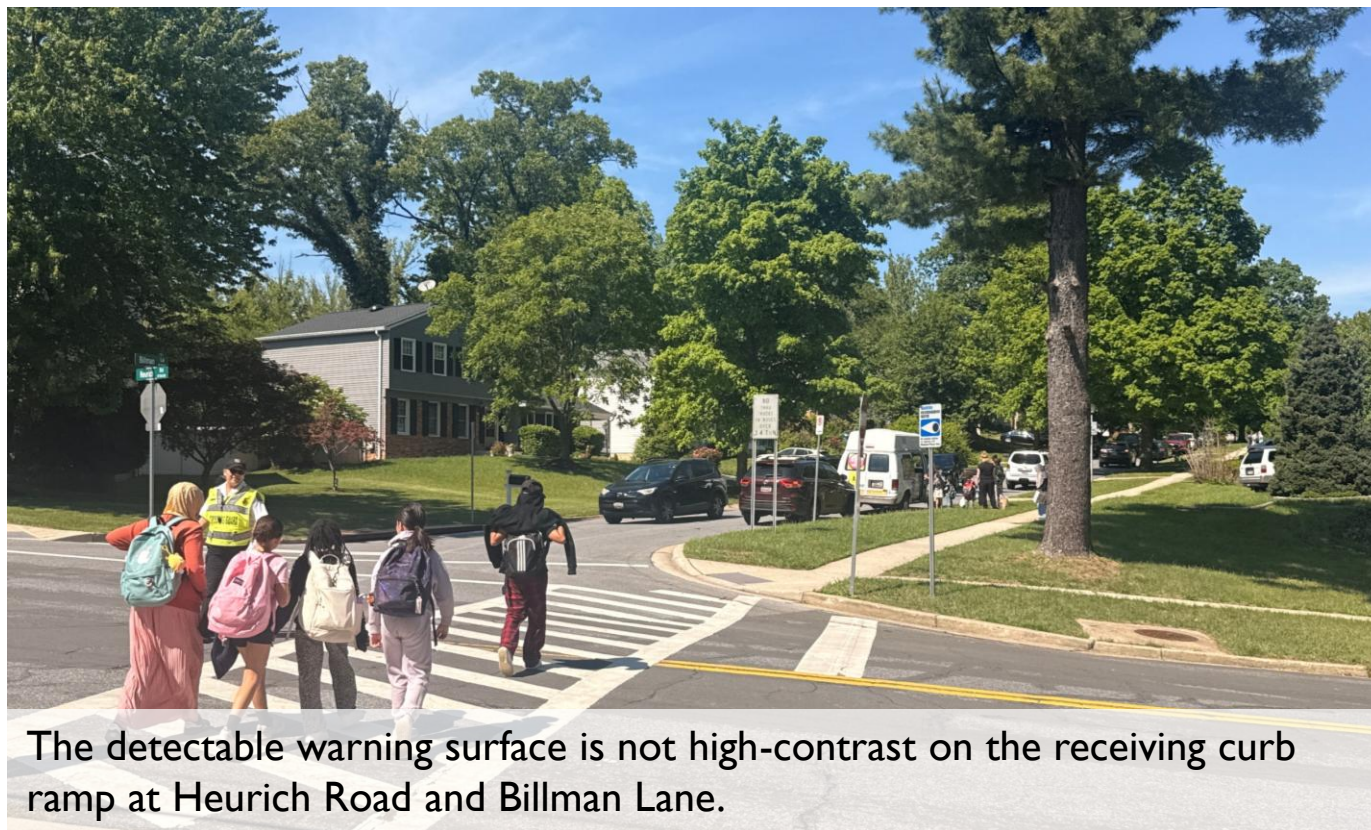
The detectable warning surface is not high-contrast on the receiving curb ramp at Heurich Road and Billman Lane.

| MAP ID | LOCATION | ISSUE | RECOMMENDATION | COST | TERM | JURISDICTION |
|---|---|---|---|---|---|---|
| 9 | Heurich Rd & Billman Ln | Receiving curb ramps for crossing across Billman Ln on the north side of Heurich Rd do not appear to be ADA compliant. | Reconstruct or repair existing ramp. | \$ | Short | MCDOT |

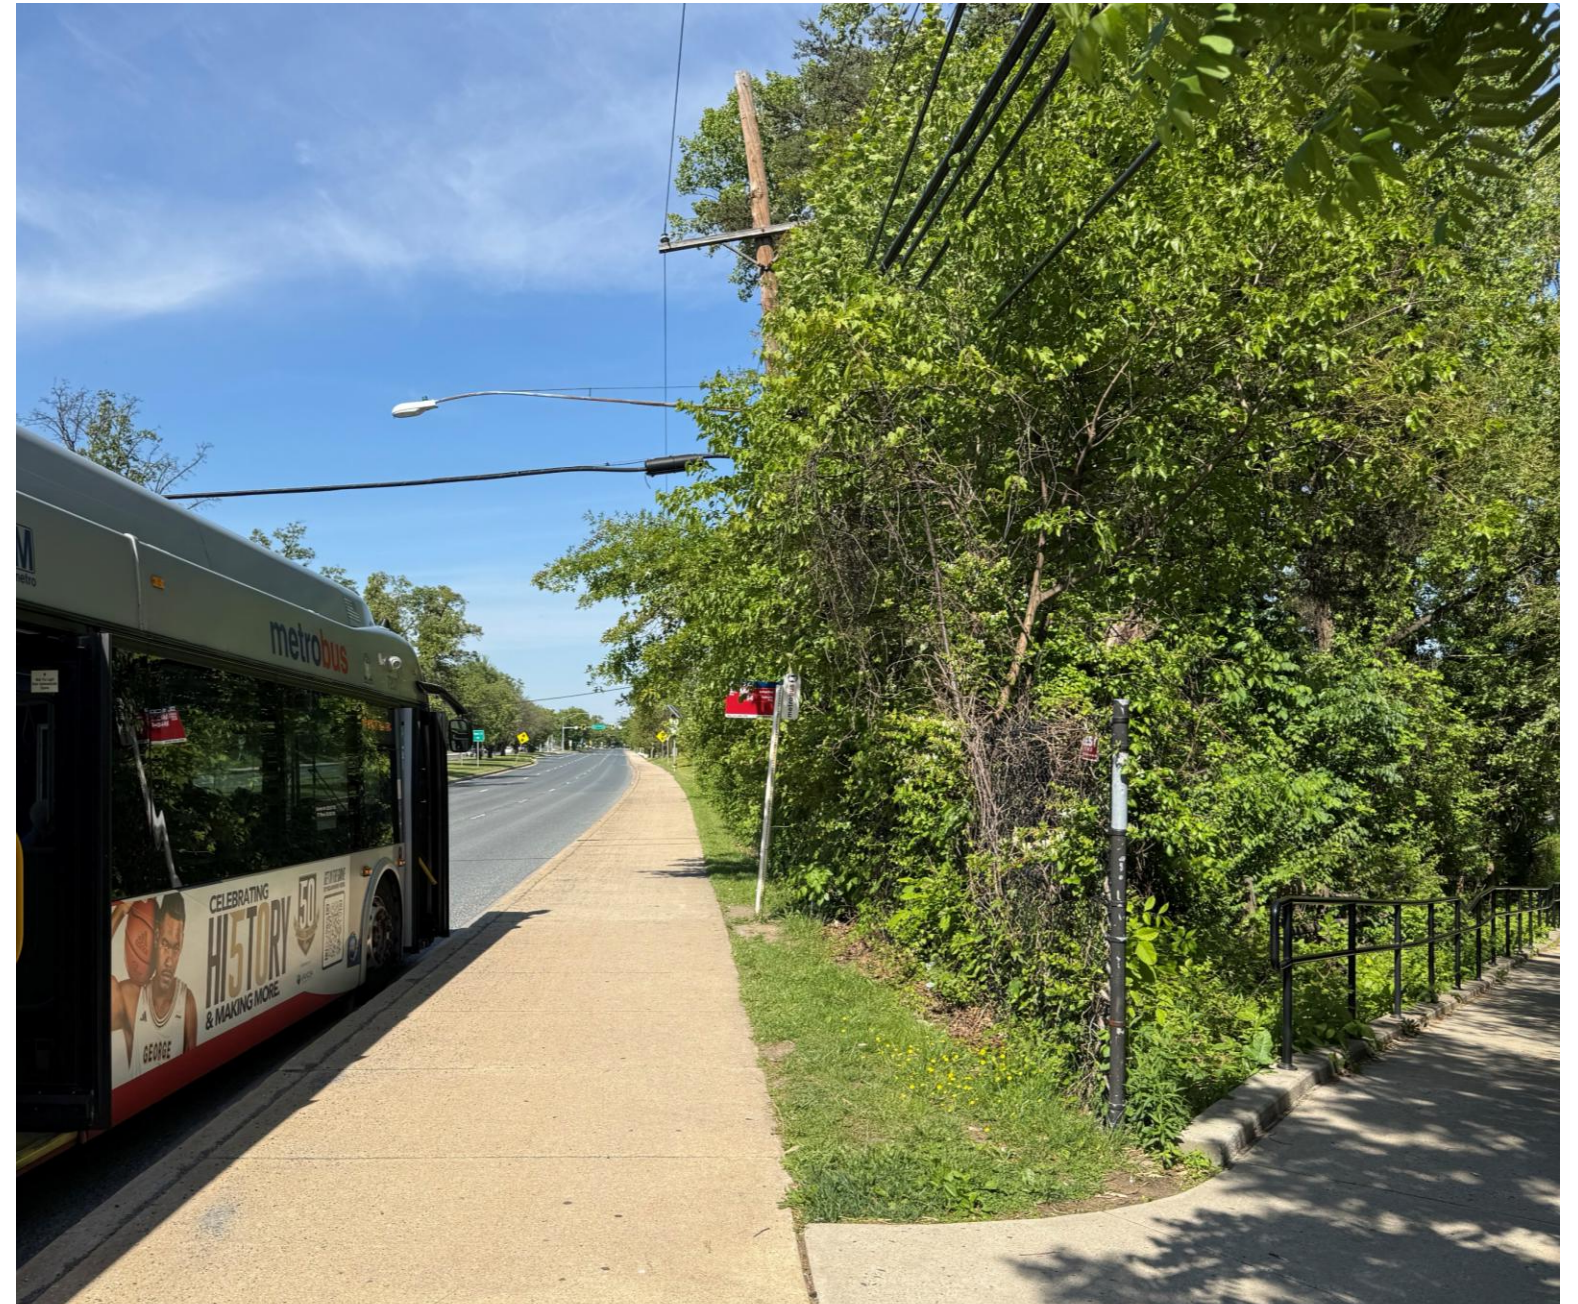
Eastbound bus stop on Randolph Road near Glenallan Avenue intersects walkway leading to the back entrance of the school.

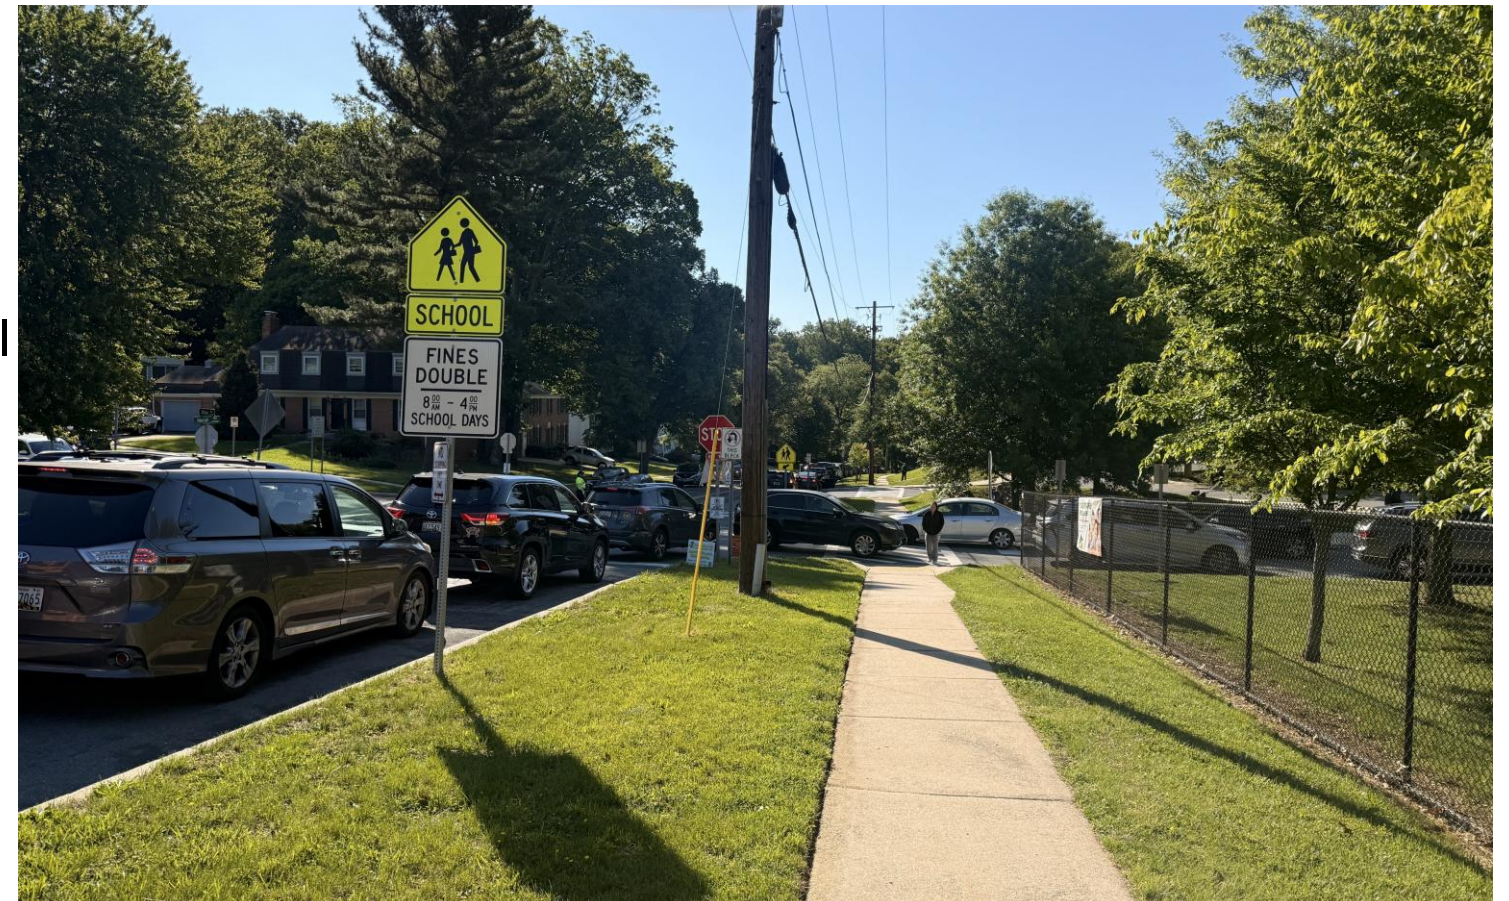
Vehicle drop-off queue blocks the crosswalk during arrival.

- Cars in the pick-up queue consistently block the school driveway crosswalk, especially during peak times when students are crossing.
- Greater number of students were observed crossing Randolph Road all at once. With some running to cross Randolph Road immediately after exiting the pathway - bypassing the sidewalk and curb ramp. This is a major safety concern given visibility issues for vehicles turning right from Glenallan Avenue and traveling eastbound on Randolph Road.

| MAP ID | LOCATION | ISSUE | RECOMMENDATION | COST | TERM | JURISDICTION |
|---|---|---|---|---|---|---|
| 7 | Heurich Rd & Billman Ln | <ul style="list-style-type: none"> <li>The car pick-up and drop-off queue often blocks the crosswalk across the school driveway while students are actively crossing.</li> <li>Concerns about driver turning movements and speeds. Cars were observed making fast-speed turns both when entering and exiting the school driveway and when turning from Billman Ln onto Heurich Rd. Vehicles park east of the intersection along the north and south side of Heurich Rd, impacting sightlines for students crossing Heurich Rd.</li> <li>Crosswalk markings are not high-visibility for crossing across Billman Ln on the north side of Heurich Rd.</li> <li>Curb ramps for crossing across Heurich Rd on the east side of Billman Ln do not appear to be ADA compliant.</li> <li>School crossing sign at the southeast corner is not fluorescent yellow/green per MUTCD.</li> </ul> | <ul style="list-style-type: none"> <li>Install high visibility crosswalk across school driveway.</li> <li>Install curb radii reductions on the north corner of the intersection and the west corners of the school driveway.</li> <li>Install curb extensions on Heurich Rd on the east and south corners of the intersection, at the existing marked crosswalk. This will prevent parking near the intersection and improve sightlines for students crossing Heurich Rd. A large catch basin located on the south side of Heurich Rd may impact ability to install a concrete curb extension; consider a paint and flexpost curb extension as an alternative.</li> <li>Install new high-visibility crosswalk.</li> <li>Reconstruct or repair existing curb ramp.</li> <li>Update school crossing sign.</li> </ul> | \$\$ | Mid | |

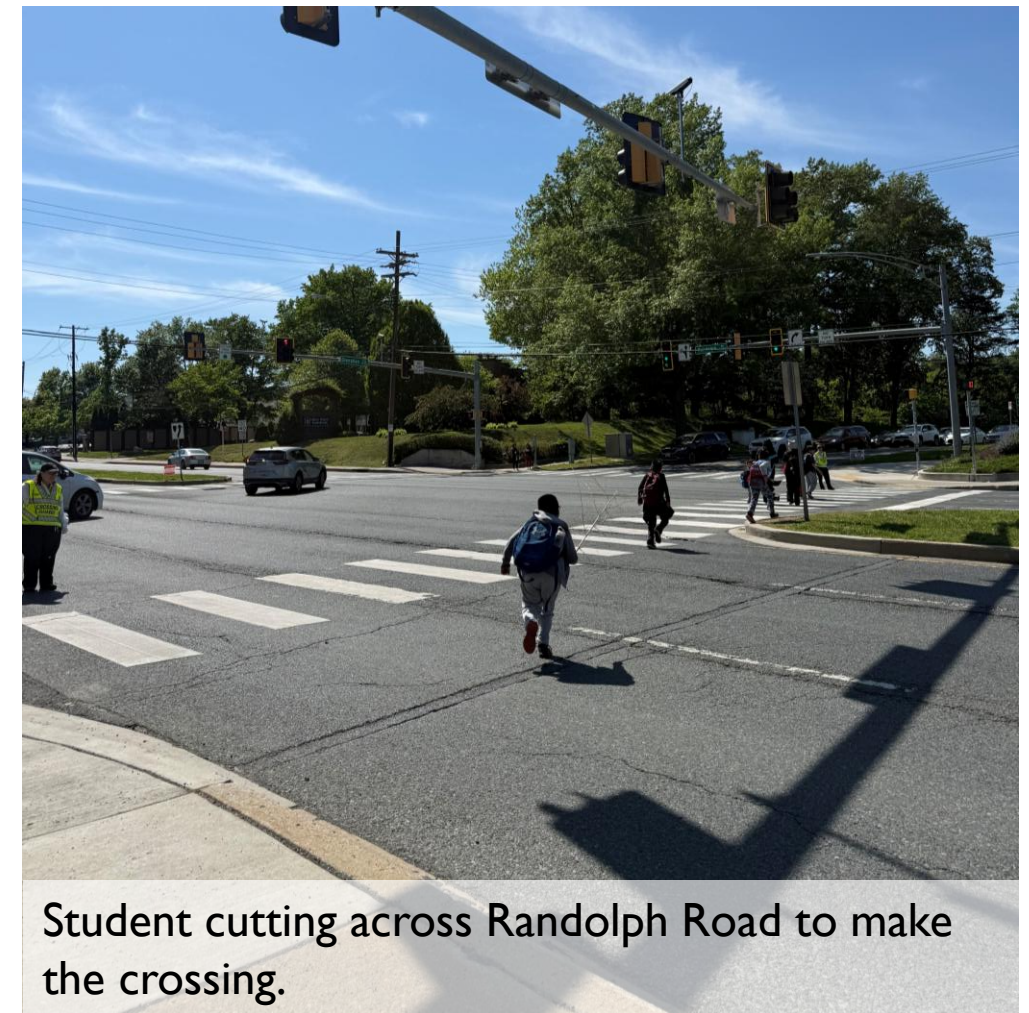
Student cutting across Randolph Road to make the crossing.

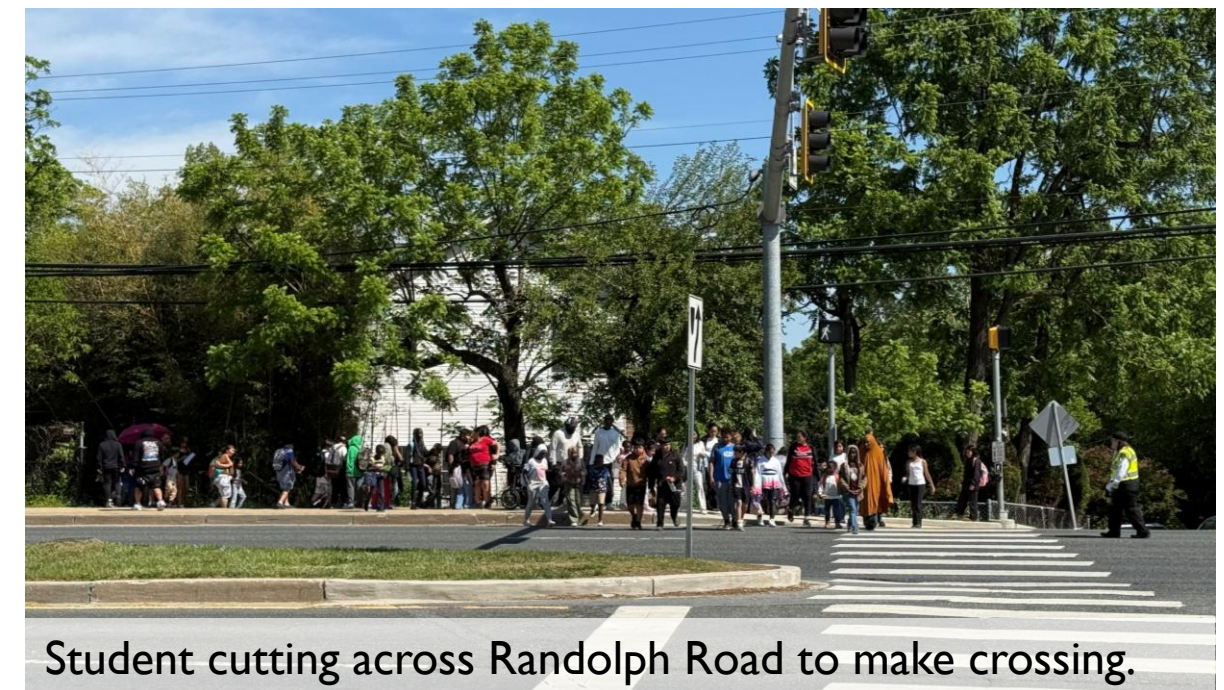
Student cutting across Randolph Road to make crossing.
